How to Eliminate ESP Insulator Thermal Break Down and Insulation Aging

Long Tao, Xu Jian, Zhou Baoshan

*Nanjing Tailong Special Ceramics Co., Ltd.
East End of Shennong Road, Jixiang'an, Nanjing 210038
China*

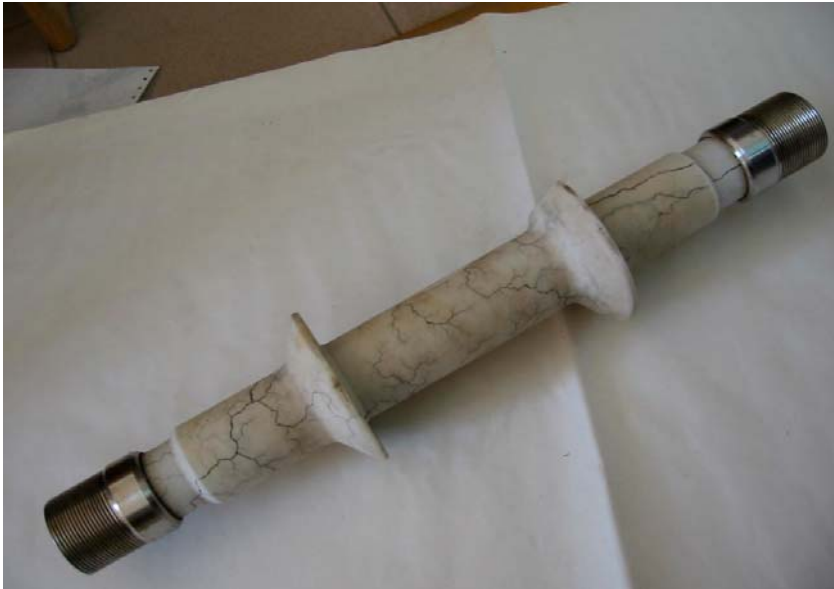
Gas breakdown induces local corona discharge, mass quantity of positive and negative ions impacting solid surface, causes aging of insulator. Arborization trace can be observed (Fig.2)

Fig. 2 Arborization trace on insulator surface

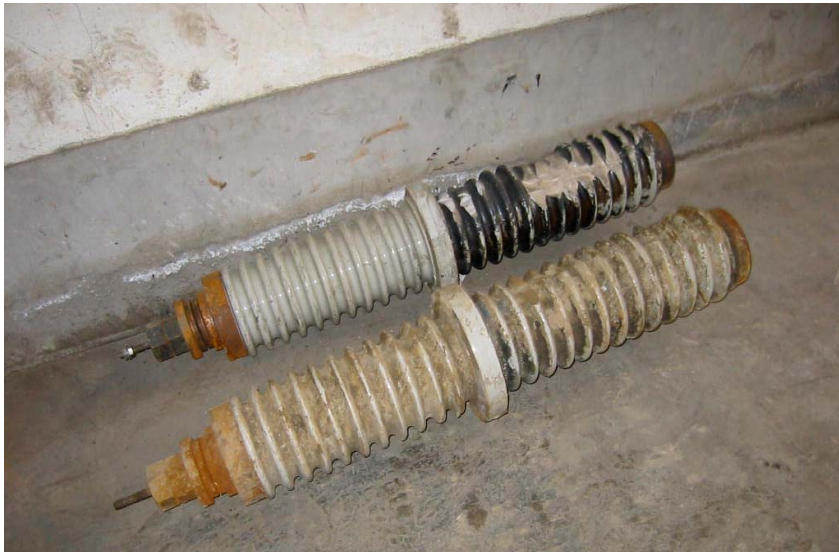
Its working life had only to be 20~40days. All were damaged at hot ends (Fig.3).

Fig. 3 Damaged insulators

We have tested this bushing. Good insulation at 26°C. No breakdown and temperature rising under DC voltage 108kV. Arc discharging under 140kV at cold end. At 150°C, "zz...zz..." sound was heard and corona discharge occurred near its flange when voltage gradually increased to 15kV. Under 34.6kV, breakdown happened. At 200°C, breakdown happened under 11kV. At 250°C, breakdown happened only under 2.7kV.

So, we can conclude that thermal breakdown is the factor causing insulation failure for this wall Bushing.
